Ultrasonic imaging—A novel way to investigate corrosion status in post-tensioned concrete members

SHIVPRAKASH IYER,^{*†} ANDREA J. SCHOKKER^{††}, SUNIL K. SINHA,[§]

Civil & Environmental Engineering Department, 212 Sackett Building, The Pennsylvania State University, University Park Campus, PA 16802. USA. [†]Phone: (814) 863 0501, Fax: (814) 863 7304, email: shiv@psu.edu; ^{††}Phone: (814) 863 2786, Fax: (814) 863 7304, email: ashock@enr.psu.edu; [§]Phone: (814) 865 9433, Fax: (814) 863 7304, email: sunil@enr.psu.edu

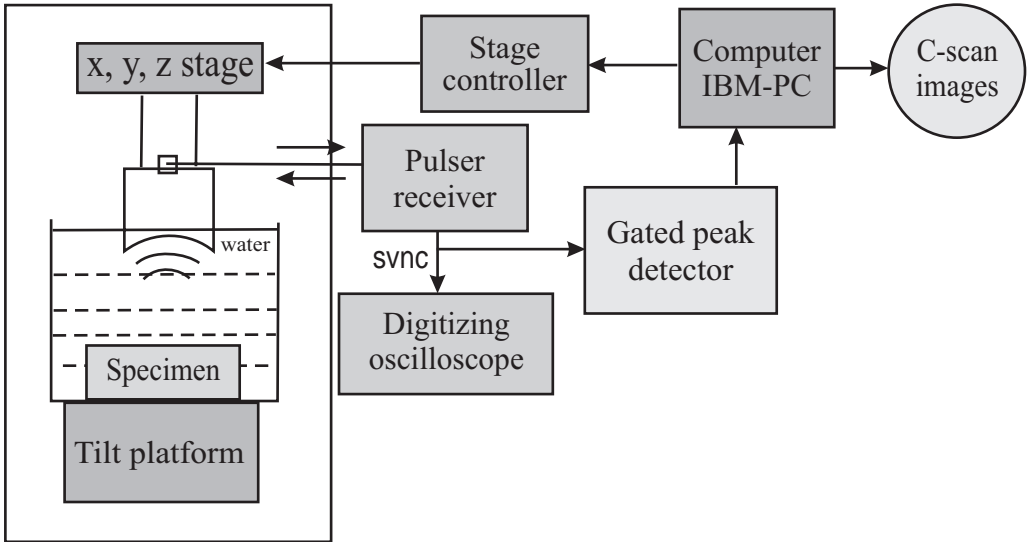
FIG. 3. A block diagram of C-scan imaging set-up.

An Ultrason NDC 7000 system in C-scan mode was used in conjunction with a focused transducer with a center frequency of approximately 500 kHz. A block diagram of the set-up is shown in Fig. 3 [16]. The specimens to be examined were submerged in a water tank. The focused transducer, made of single-crystal sapphire, was attached to an automated computer-controlled x-y-z stage and was excited by a Panametrics Pulser-Receiver (Model 5601A/ST) to generate ultrasonic waves [17]. The focused transducer consisting of the transmitter and receiver was housed in the same assembly thus resembling a single unit transmitter-cum-receiver. The focused beam was reflected by the specimen and returned to the transducer, which also acted as a receiver. The signal reflected from the back surface of the examined plate was gated, and its peak value provided the data for the C-scan image of each gate. The transducer output signals, digitized by a Tektronix TDS-540 four-channel digitizing oscilloscope and processed by a Panametrics Gated Peak Detector (Model 5608), were then acquired using a personal computer to produce a C-scan image. The signal reflected from the bottom surface of the specimen was maximized, and then the transducer was defocused from the back surface to give the best image. This signal was gated, and its peak value provided the data for the C-scan image.

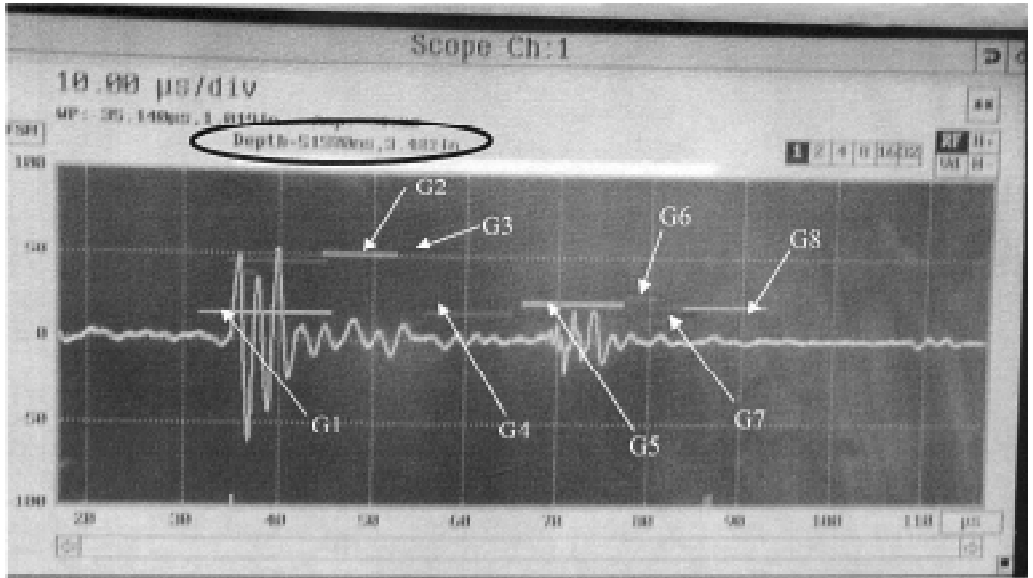
FIG. 4. Signal with flaw gate location.

data gates (G1–G8) per channel for collecting peak amplitude and time-of-flight. In addition, the operator has control of front surface and sub-surface follower gates (for interface synchronization of data gates), phase gate (detects a signal phase inversion), and a B-scan gate (for collecting B-scans). Dynamic gating allows the system to adjust automatically the data gate width to back wall thickness variations. Delta time-of-flight (Δt) displays thickness variation with an accuracy of 0.0002". Figure 4 shows the location of these flaw gates on a signal displayed in the oscilloscope.

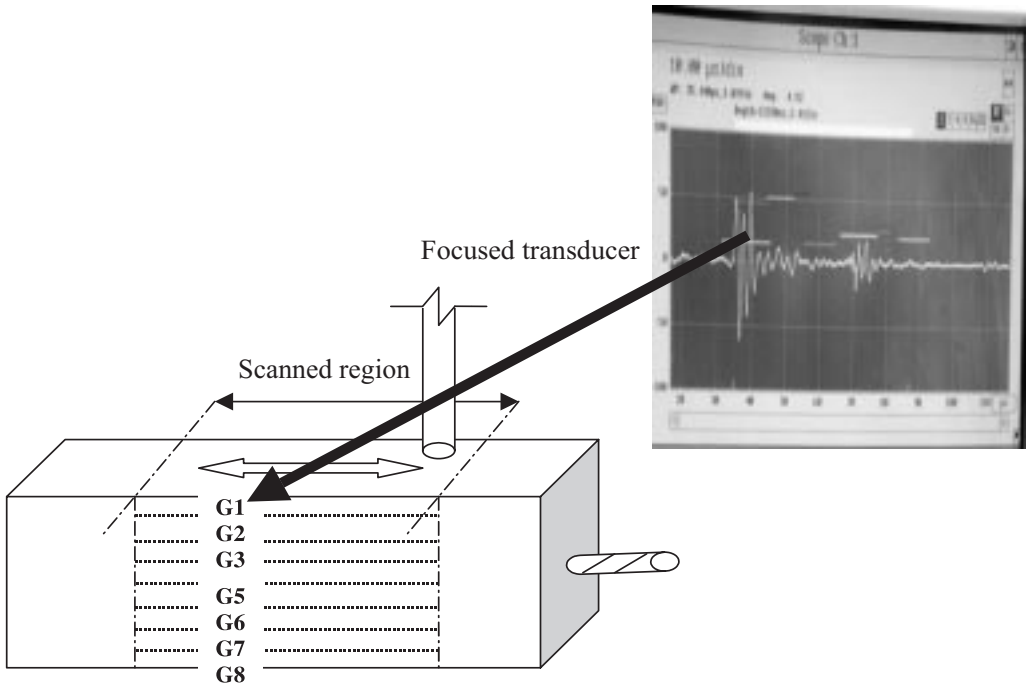
FIG. 6. Flaw gate location on sample and significance.

width of the signal from the top, center (tendon location) and the bottom of the sample. This is important from the point of view of depth and region covered by ultrasound beam. The significance of this action is that the gate width directly corresponds to the width of the region from which the signal reflects. The diagram in Fig. 6 represents the correlation between the location of flaw gates on the signal and the region it represents on the sample.

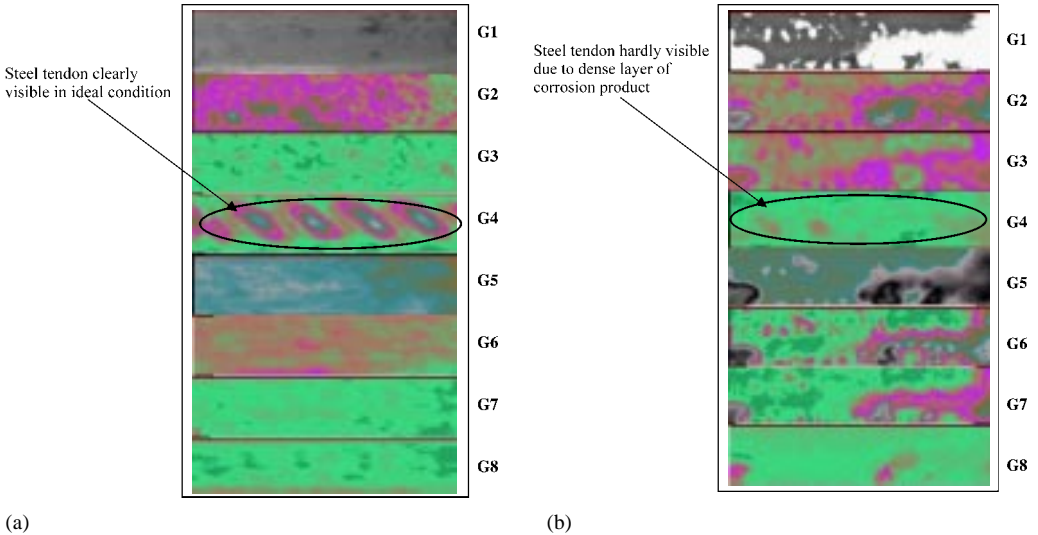
(a) (b)
Fig. 7. Images from all gates for (a) plain grouted and (b) fully corroded specimens.

The plain grouted specimen was prepared with utmost care to ensure that no voids or corrosive agents entered the grout during the mixing or casting stage. It is essential to have a suitable neatly grouted specimen as the ideal case in the field where no corrosion or voids are present. The C-scan image for each of the gates is shown in Fig. 7. The gates have been stacked together in the figure to show a representative slice through the duct and strand as represented in C-scan images. Gate G4 clearly shows the twist of the prestressing strand, while the other gates return a basically solid image.

corrosion may be detected. Figure 7(b) shows the C-scan images for each gate for the corroded specimen. Gate G4 only shows a faint pattern of two twists of the prestressing strand, while the rest is not clear due to the accumulation of corrosion product. The corrosion product in this specimen was extensive, continuing through the grout up to the interface between the PVC casing and the grout, causing a debonding at this interface. The image from G1 clearly indicates that the reflection from the interface of grout and PVC casing is not strong enough to render a clear image and a lot of energy has been dissipated. Energy dissipation may occur due to debonding in the material that has resulted from the action of corrosion of the tendon. Debonding creates energy wells in the atomic structure of the material wherein the ultrasound beam energy is absorbed and dissipated. Hence, the desired reflection–transmission is not achieved and the signal captured by the gates explains the condition of the specimen and the tendon internally. Figure 8 shows the signal from G4 for a plain and a fully corroded specimen. There is a clear and distinct pattern indicating the presence of anomalies within the fully corroded tendon. Autopsies done on the specimen after testing confirm the images to a satisfactory level. Figure 9 shows the autopsied view of the fully corroded specimen.

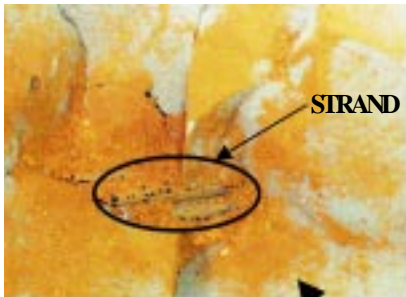
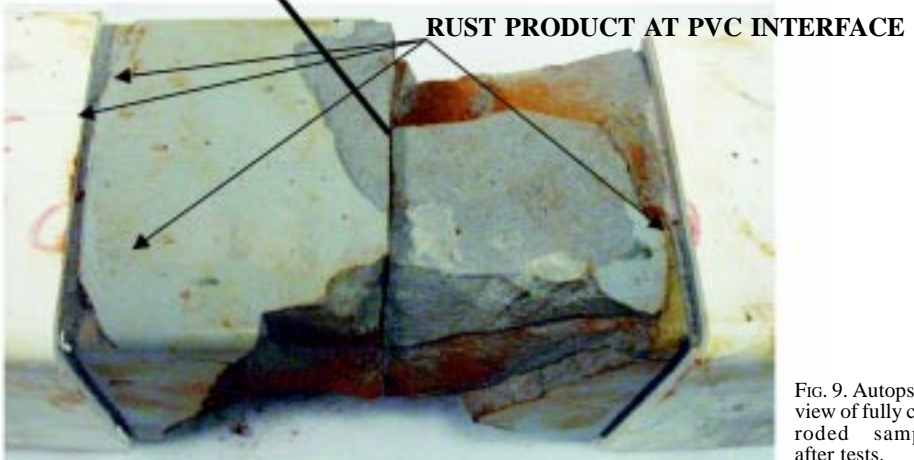
FIG. 9. Autopsied view of fully corroded sample after tests.

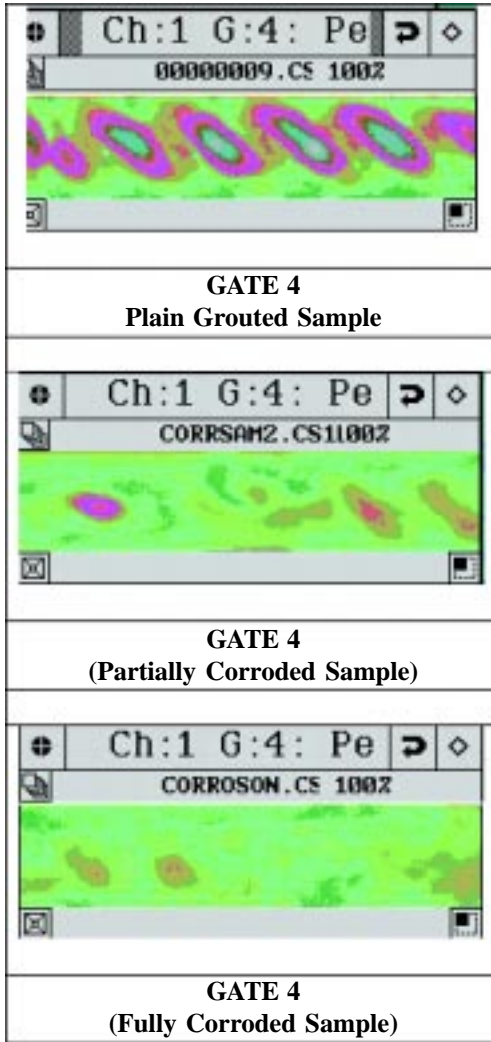
FIG. 10. Comparison of images of plain grouted, partially and fully corroded samples from gate G4.

The partially corroded sample as compared to the fully corroded one has a lesser extent of debonding around the tendon and so the energy available for reflection is higher than in the fully corroded one. For this reason, in spite of corrosion products around the tendon, some parts of the tendon do reflect the ultrasound beam, as it is intact and uncorroded. Figure 10 is a G4 image comparison from a plain grout, partially corroded and fully corroded sample. A few additional steel strands can be seen in the partially corroded specimen. A clear distinctive pattern in representation of the tendon is observed between the ideal condition (plain grout) specimen and samples with two levels of corrosion.

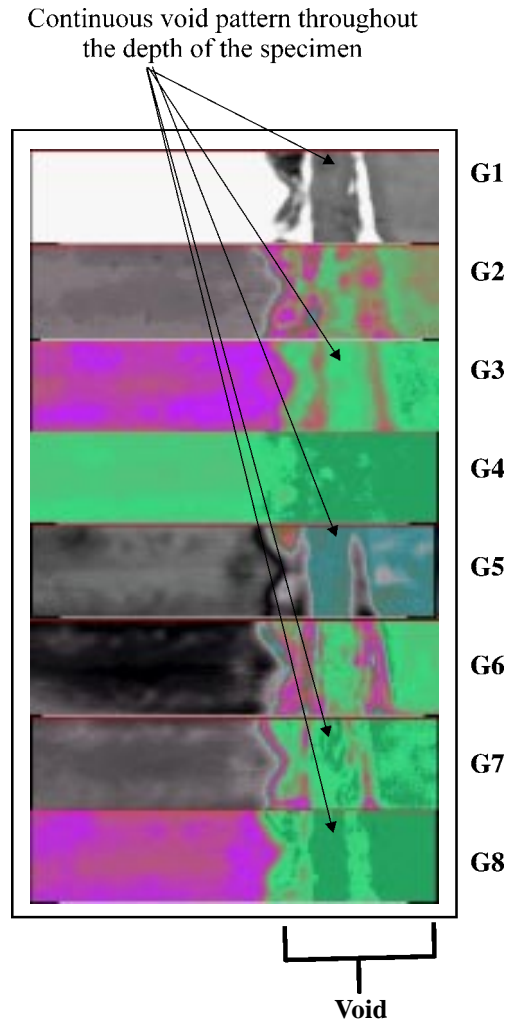
FIG. 11. Complete image capturing from G1–G8 for a voided specimen.

Figure 11 shows the C-scan images for each gate for the partially voided specimen. The void is clearly seen in each gate; however, the tendon is not clearly seen in gate G4. In this case, the tendon twist should be evident, but this is likely due to a misalignment of the tendon. If the tendon is moved from the central position, gate G4 will be aligned with the tendon. When this equipment is developed for field use, gates will be adjusted for closer spacing so that strands are not missed. In field specimens, not only do we not know the exact location of the strand, but often multiple strands will also be present. Figure 12 shows the actual voided specimen.

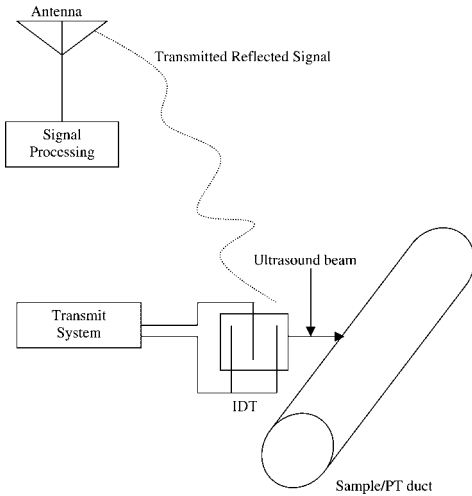
FIG. 13. Schematic of a wireless data acquisition and processing for ultrasound C-scan imaging technique.

- A wireless transducer integrated with an ultrasound C-scanning system that can scan and catch data from the post-tensioned duct with little or no contact with the structure will consist of a very sophisticated measuring system. A remote antenna system needs to be devised to capture the reflected signals from different depths by means of flaw gates. An interdigital transducer (IDT) is cable-connected in order to supply the appropriate voltage required to power the scanning system. The schematic for wireless telemetry system for corrosion/void detection in the field using ultrasound C-scan system is shown in Fig. 13.
- The final field equipment must be tested on a large number of tendons under a wide range of conditions to ensure that the method is robust for field application.
