Microbiologically influenced tuberculation of carbon steel

R. P. GEORGE*, P. MURALFEDHARAN*, T. S. RAO** AND H. S. KHATAK*

*Corrosion Science & Technology Division, **Water and Steam Chemistry Laboratory, Indira Gandhi Centre for Atomic Research, Kalpakkam 603 102, India

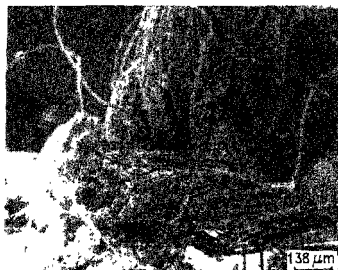
FIG. 15. SEM photograph of thick iron bacterial filaments on coupons exposed to cooling-water system.

The present study on CS tuberculation has important relevance with respect to the problems of corrosion and tuberculation in cooling-water systems. Figure 15 shows thick iron bacterial filaments on CS specimens exposed to the cooling-water system of one of the reactors in Kalpakkam. Filaments of IOB, found in our CS specimens used for laboratory studies are shown in Fig. 16. The present study has shown that although the tuberculation of CS is initiated by IOB, the growth of tubercles is maintained under constant supply of oxygen irrespective of the bacterial density. Hence, treatment with biocides and chlorine must be undertaken in a clean system to prevent tubercle initiation. In an infested system under-deposit attack may progress unless steps are taken to disrupt the oxygen-concentration cell which appears to be the principal mechanism of carbon steel tuberculation.
